V1910-CMW520-R1512P10 Release Notes

Comware software, Version 5.20, Release 1512P10

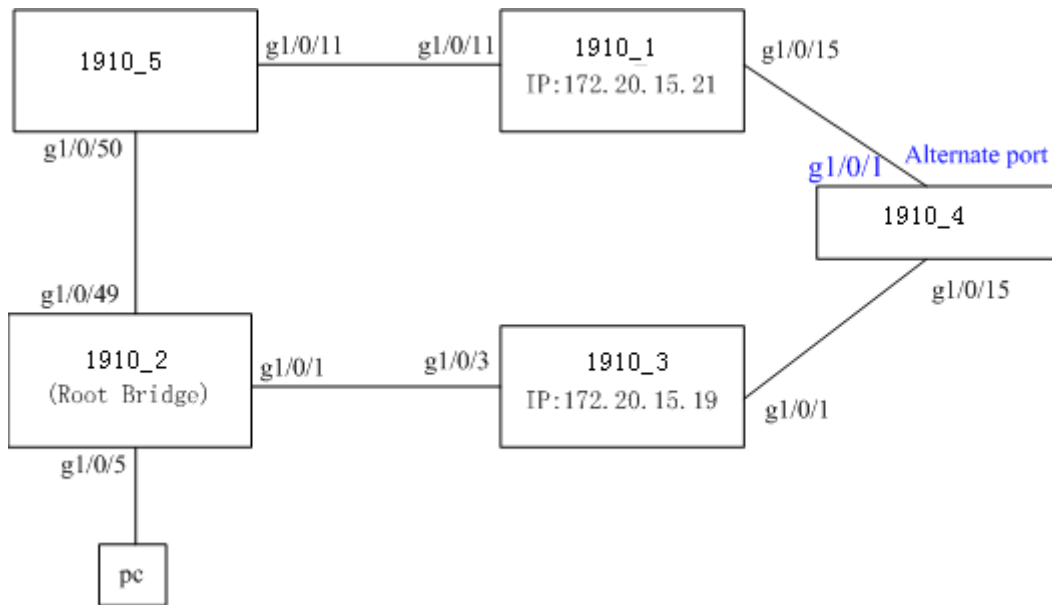
LSD44945

- Symptom: In the following network diagram, a ping operation from the PC to 1910_1 experiences a 30-second interruption.
- Condition: This symptom might occur when the following conditions exist:
 - All 1910 switches and the PC are in the same subnet.
 - MSTP is configured to avoid loops and all 1910 switches belong to MSTP instance 0.
 - The port G1/0/49 of the root bridge 1910_2 is shut down.

- Workaround: Configure the **stp no-agreement-check** command on the root ports.
