# V1910-CMW520-R1513P85 Release Notes

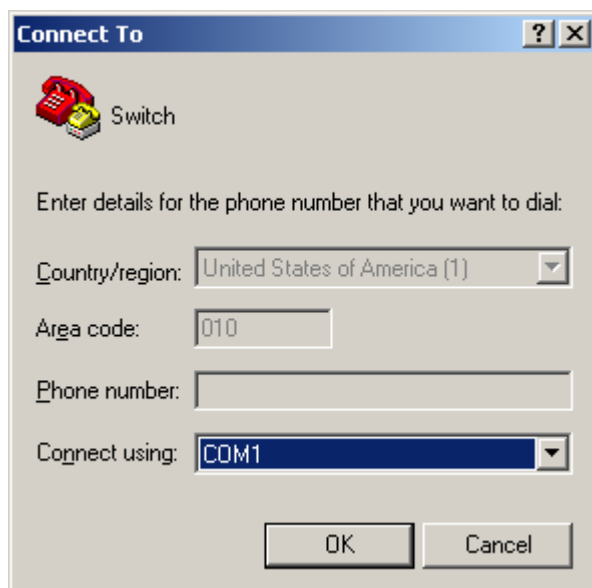
**Figure 2 Set the serial port used by the HyperTerminal connection**

**Step2** Select the serial port to be used from the **Connect using** drop-down list, and click **OK**.
